INDIANA DEPARTMENT OF ENVIRONMENTAL MANAGEMENT
We make Indiana a cleaner, healthier place to live

Re: Gary Development Company Landfill
RCRA Docket No. RCRA-V-W-86-R-45
EPA I.D. No. IND 077 005 916

On November 19, 1996, a visit to the above-captioned site was made by myself and Mr. Kirk Maravolo of the Indiana Department of Environmental Management, representatives of U.S. EPA Region V, and Mr. Steve Cherry and Ms. Lisa McKinney from Bose, McKinney & Evans. Enclosed, as previously requested, are two (2) additional photographs that were obtained by Mr. Maravolo during this visit.

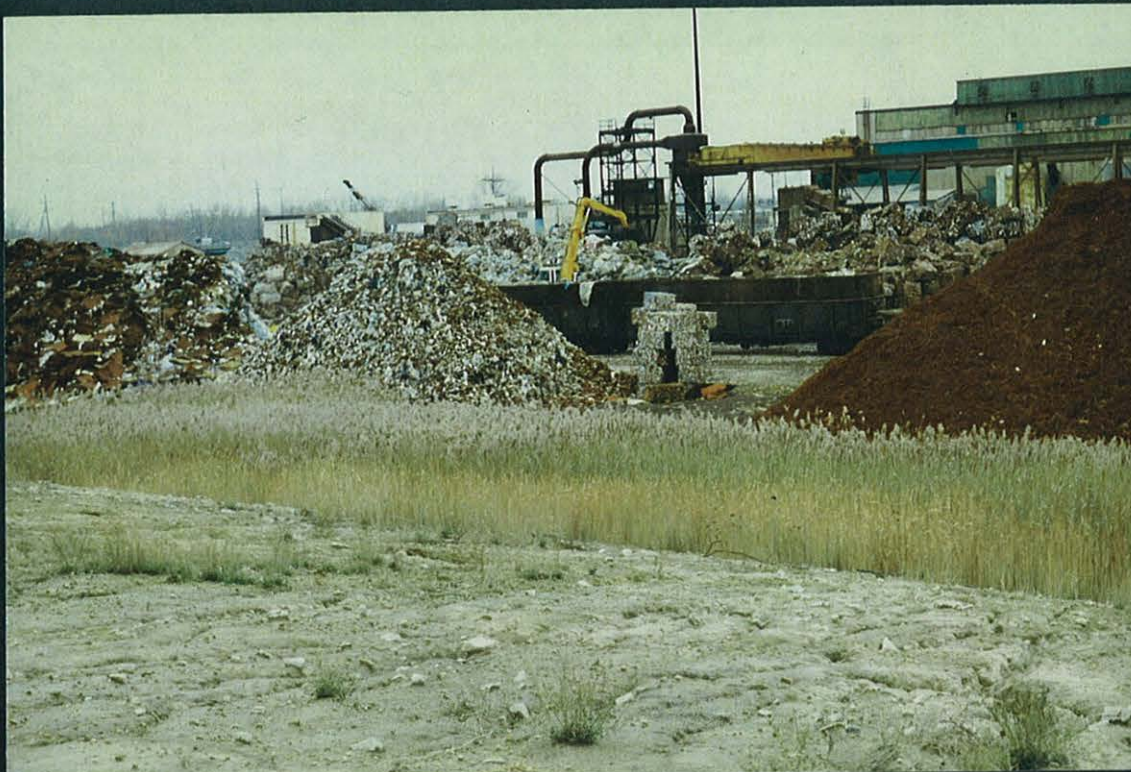
11-19-96 M. Mikulka
Gary Development Landfill
#22 -- View of AMG Resources
facility as seen from W. Side of
GDC Property. Note western face

of landfill in foreground, and
depressed area at toe of slope,
where storm water from western
portion of landfill drains.
